THE  
ECCLESIASTICAL  
ARCHITECTURE  
OF SCOTLAND

FROM THE EARLIEST CHRISTIAN TIMES TO THE  
SEVENTEENTH CENTURY

BY  
DAVID MACGIBBON AND THOMAS ROSS  
AUTHORS OF "THE CASTELLATED AND DOMESTIC ARCHITECTURE OF SCOTLAND"

VOLUME ONE

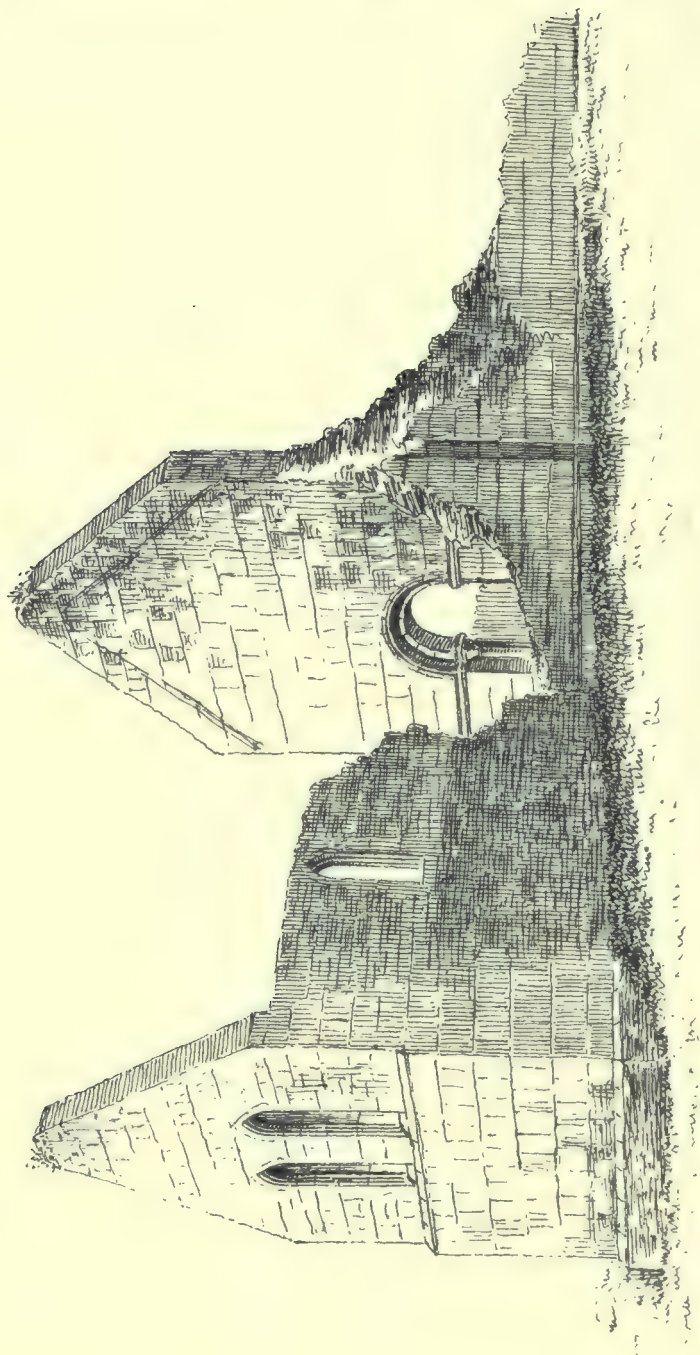
FIG. 248.—St. Blane's Church. From North-East.

At first sight the structure at once impresses one as being a Norman building (Fig. 248), from the style of the masonry of the lofty central wall and the east end, which stand out prominently from amongst the ruins. On closer inspection, the church is found to consist (Fig. 249) of an oblong nave, 50 feet 6 inches in length internally by 16 feet 8 inches in width, and a chancel, 26 feet 3 inches long by 13 feet 11 inches wide, separated by the lofty wall above referred to. The latter contains a chancel arch, 5 feet 3 inches in width.

the stones. The lower rubble portions of the side walls contain no openings, but the upper freestone portions contain windows. The window in the north wall (see Fig. 248) is a single-pointed light, with freestone ingoings and sconsion arch. There has at one time been a similar one-light window in the south wall, but at a later date a two-light window has been introduced instead of it. The latter being placed at a higher level than the former, part of the older window still remains below the sill of the later one. The older windows in the side walls are moulded on the jambs; the later one is splayed. A piscina has also been inserted in the south wall close to the window.

wall is carried deeper than the side walls. The lower portion (which extends also for a short way along the north and south sides) is brought up with whinstone rubble for about two feet (see Fig. 248), when a

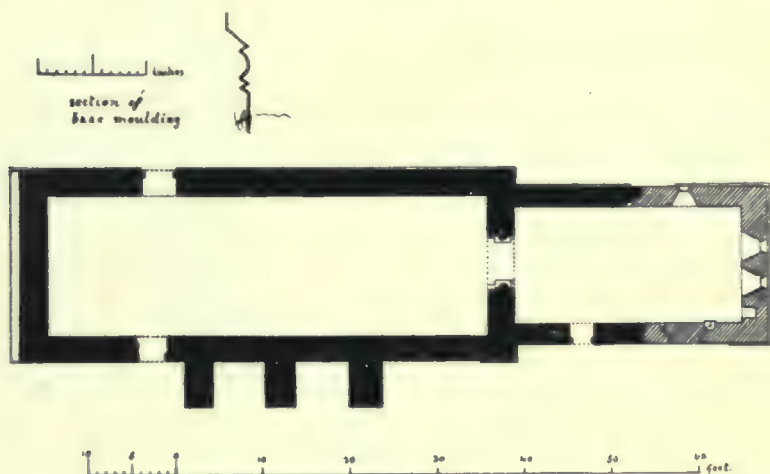
FIG. 249.—St. Blane's Church. Plan.

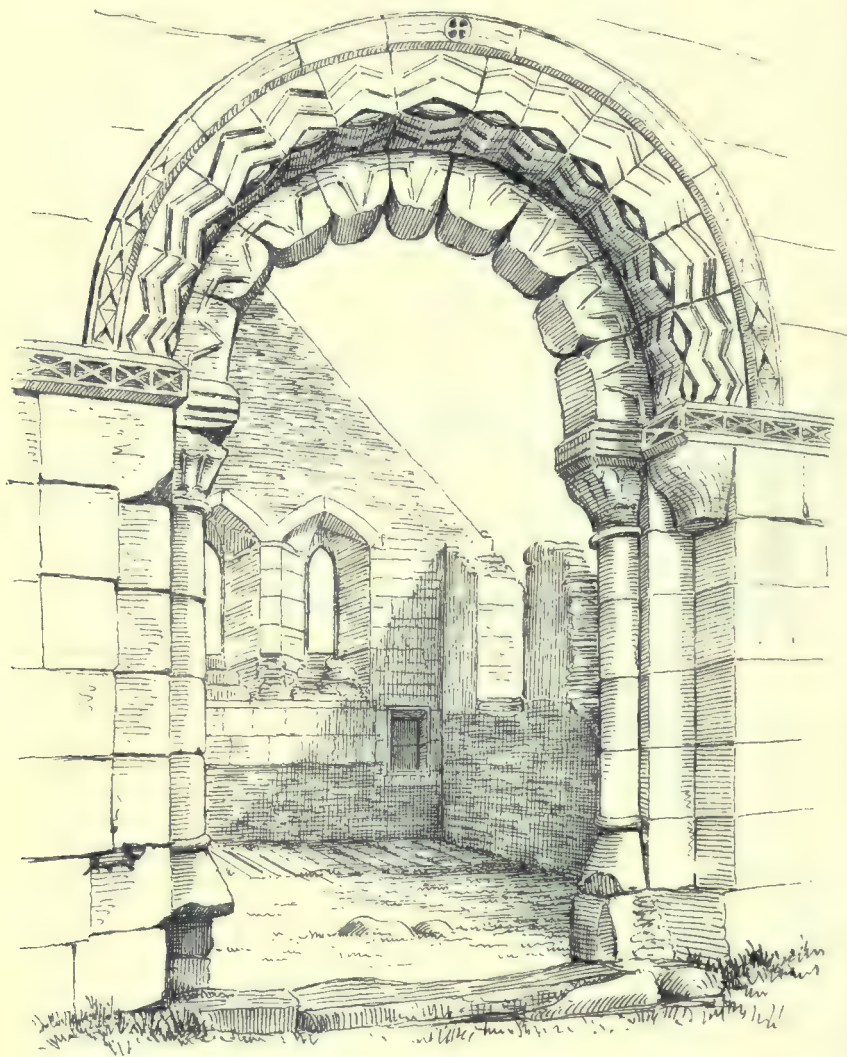
FIG. 250.—St. Blane's Church. Chancel Arch.

The chancel arch (Fig. 250) is of good Norman design. On the side next the nave it is in two orders, the inner order having a simple linear or, perhaps, bird's-beak enrichment, and the outer order is enriched with two series of chevrons, one on the face and the other on the soffit, which leave on the angle a raised lozenge form between them. The arch is enclosed with a label of three-sided section, enriched with a lozenge pattern, and having a small Greek cross in the centre of the arch. Each order rests on the cap of a shaft, the inner shafts being half-rounds, and the outer shafts complete cylinders set in nooks; but these shafts have now disappeared. The caps vary in design, but are of good Norman character.

feet (see Fig. 250), and on the exterior with rubble mixed with freestone for two courses. Above this the wall is built in the interior for two courses, and in the exterior for four courses, with carefully-constructed and jointed freestone blocks, similar to those of the nave walls. A set-off occurs on the exterior above these courses. The upper part of the wall and the exterior of the gable are composed of freestone, built irregularly, like the upper portions of the side walls. The upper portion of the interior is of similar work up to the top of the windows, above which it is of rubble work.

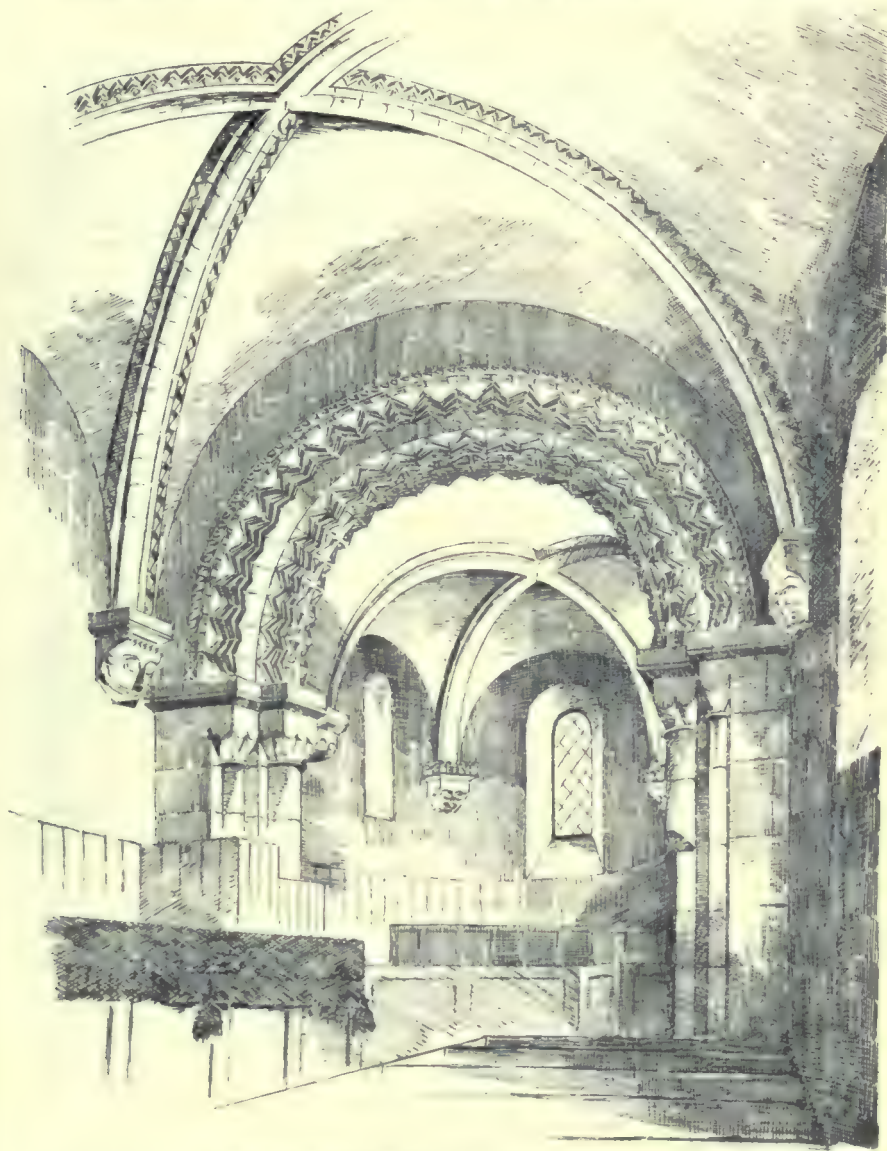
FIG. 254.—Dalmeny Church. View of Apse from Chancel.

enriched arch (see Fig. 254). The arch has two orders carved with chevron ornaments and a hood mould with faceted enrichment. The shafts and caps are similar to those of the chancel arch. The apse is vaulted like

The chancel (Fig. 254) is 16 feet long by 15 feet wide, and is vaulted with bold diagonal groin-ribs, enriched with chevron ornaments and springing from grotesque corbels (Fig. 255). It has one small window on

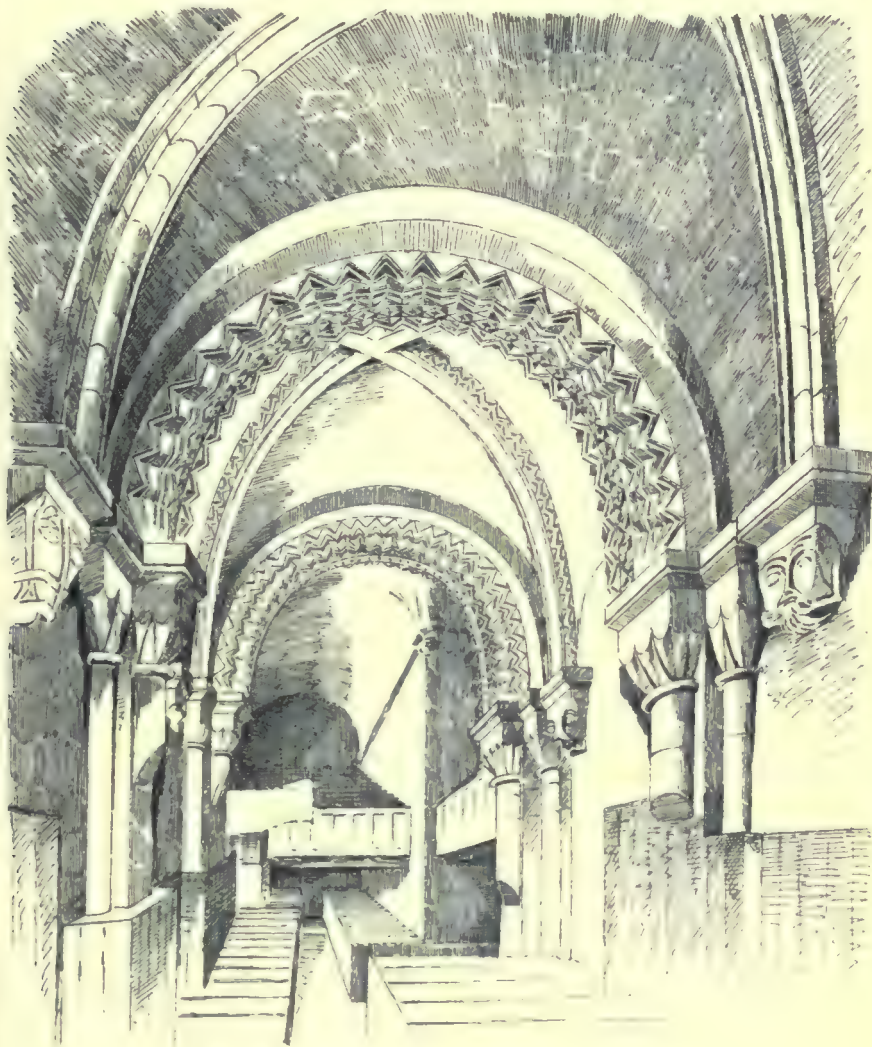
FIG. 256.—Dalmeny Church. View from the Apse, looking West.

a single square bay, with boldly moulded groin-ribs springing from large corbels carved with grotesque heads (Figs. 256 and 257). The wall is of

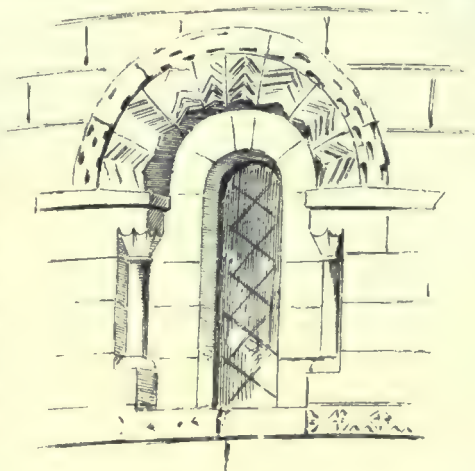
FIG. 258.—Window in Apse.

plain ashlar, and the apse is lighted by three plain window openings (Fig. 258), the central one of which has been enlarged.

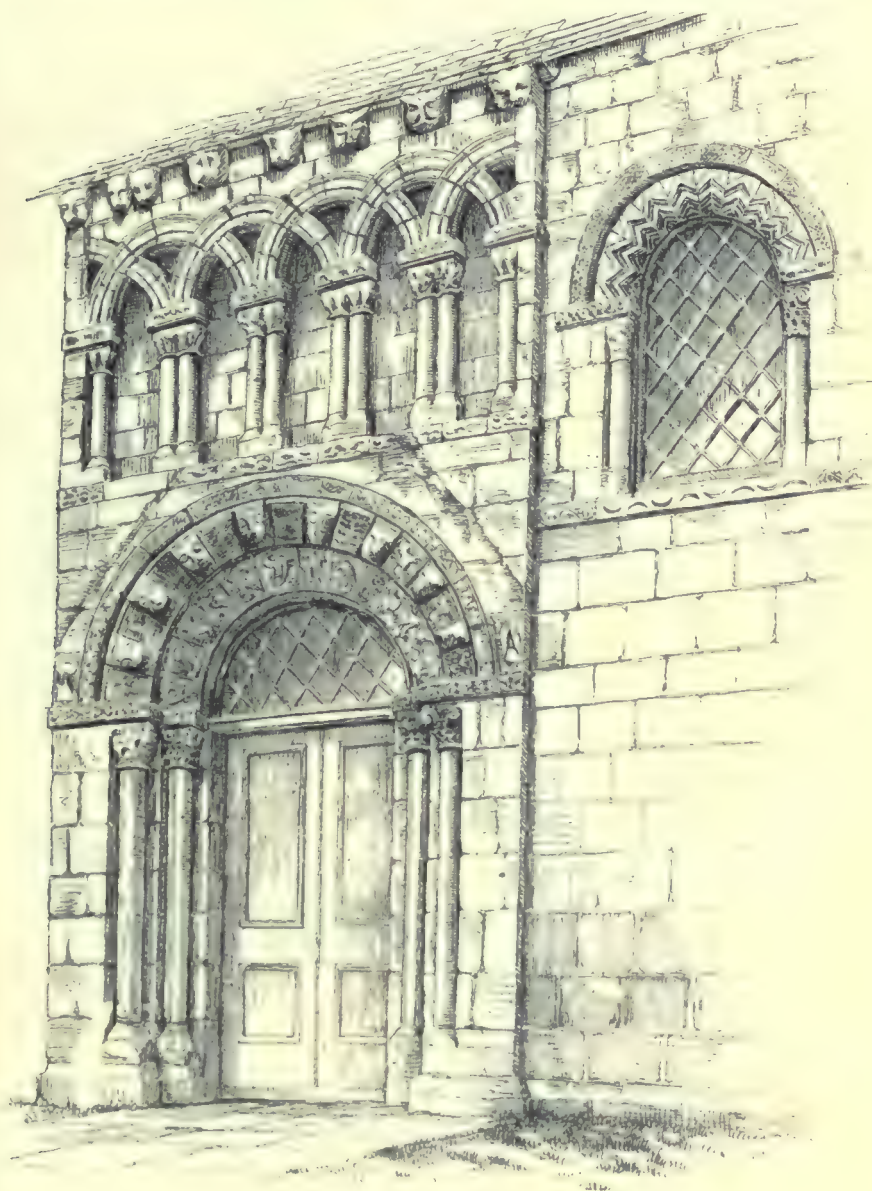
FIG. 261. -Dalmeny Church. Doorway.

The doorway (Fig. 261) is placed in a projecting part of the south wall, and is surmounted by an arcade of interlacing arches, with corbel course above, carved with grotesque heads.

The doorway has two nook shafts on each side, the outer one round

and the inner one octagonal. These are detached and in single stones. They carry enriched caps, three of them having foliage and volutes imitated from the Roman, and one with traces of an animal. A string course, enriched with scrolls, forms an abacus above the caps, and from the abacus spring the arch mouldings in two orders, with carved hood mould beyond.

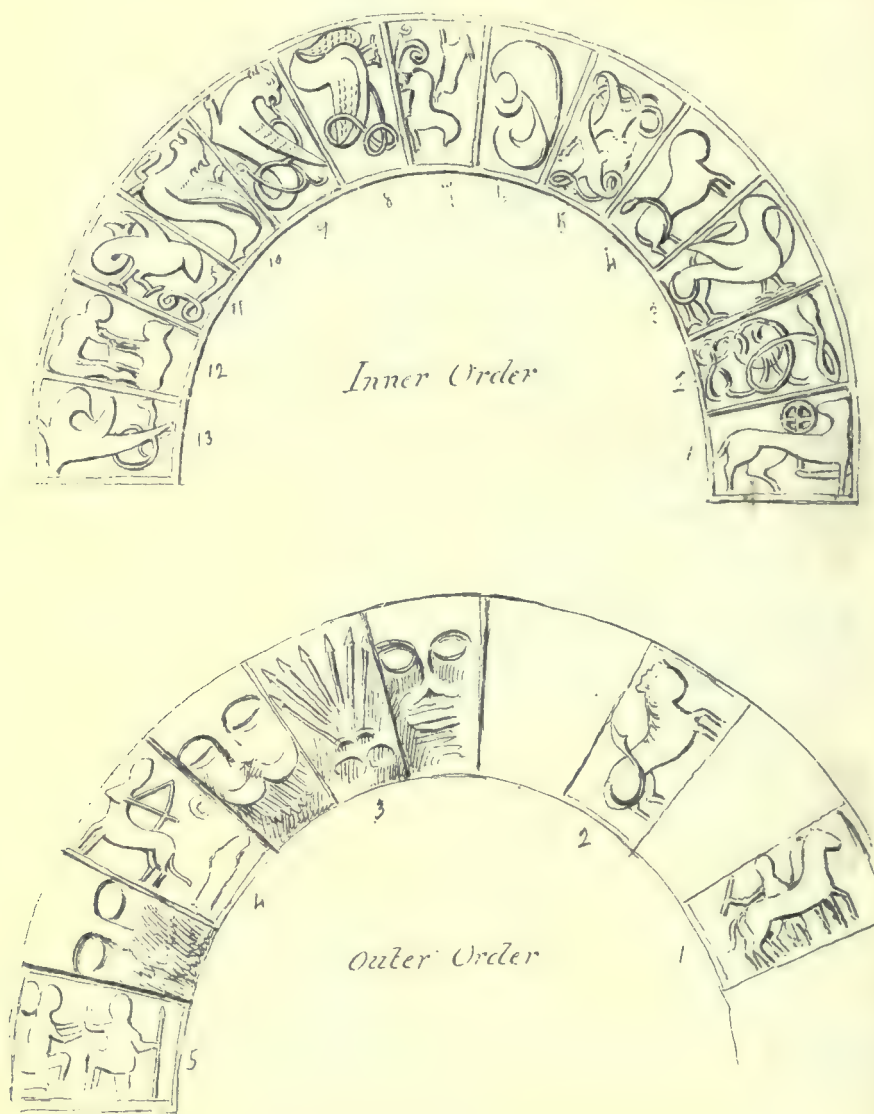
FIG. 262.—Dalmeny Church. Figures on Inner and Outer Orders of Doorway Arch.

The inner order of arches contains thirteen voussours, each of which is sculptured with a figure. These figures (Fig. 262) are very similar to those often found on the ancient sculptured monuments of Scotland, and have also considerable analogy with the figures carved on the Norman churches of England and on the Continent, thus indicating (as pointed out in the Introduction) the connection between the former and the latter. Commencing at the right-hand voussour of the inner order, we have (No. 1) a clear representation of the *Agnus Dei*, bearing the cross in sign of victory; No. 2 seems to represent a serpent, possibly with a

human head ; No. 3 represents a winged quadruped with a bird's head ; No. 4, a lion (a favourite emblem both in Norman work and Scottish monuments) ; Nos. 5 and 6 are too much decayed to be intelligible ; No. 7 seems

to be a hare running and an animal with scrolled tail at rest ; No. 8, a winged bird and serpent ; No. 9, a winged dragon with tail passing into a divided scroll, part of which it is biting with its bill ; No. 10, a winged

griffin ; No. 11, a bird with a fish's tail pecking at a serpent ; No. 12, two

seated human figures clasping hands ; No. 13, a nondescript bird and serpent.

The outer order of the arch contains eight projecting heads of grotesque form, but some of them much decayed. Alternating with these heads are voussoirs carved with figures somewhat similar to those of the inner order. These, so far as can be made out, are—No. 1, a man with a pair of horses ; No. 2, a lion, perhaps crowned ; No. 3 seems to represent a number of darts radiating from a centre ; No. 4, a centaur or Sagittarius shooting an arrow at an undefined object ; No. 5, two seated

figures, one holding a spear or pastoral staff. At each side of the arch, and resting on the string course, are two detached figures, which recall the figures similarly placed at Whithorn Priory. That on the right represents a man holding a spear, that on the left, although apparently a human figure, is too far gone to be clearly made out.

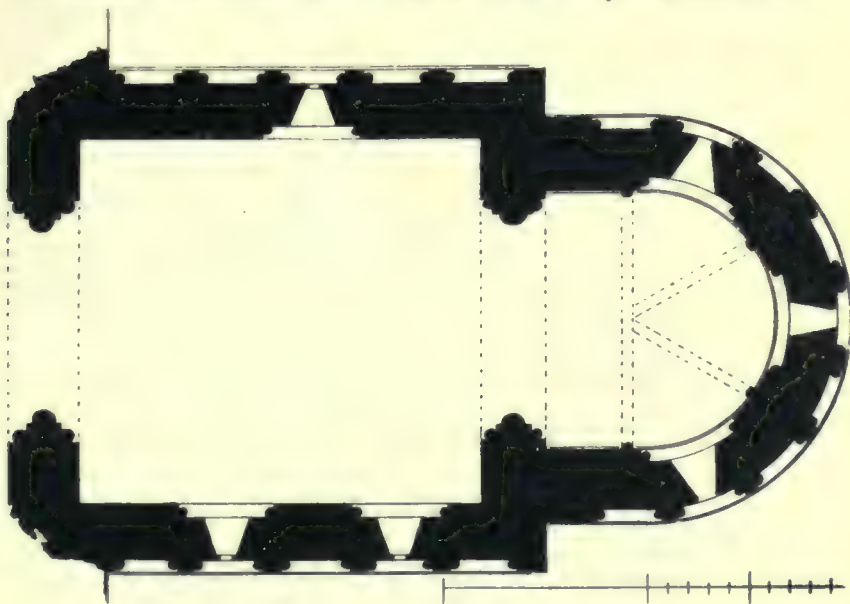
FIG. 263.—Leuchars Church. Plan.

The church (Fig. 263) now consists of a choir, 19 feet 9 inches long by 18 feet wide, with a circular apse, 12 feet 6 inches wide and 12 feet deep. There are traces of an arch at the west end of the choir, which opened into the nave; but the latter is now rebuilt.

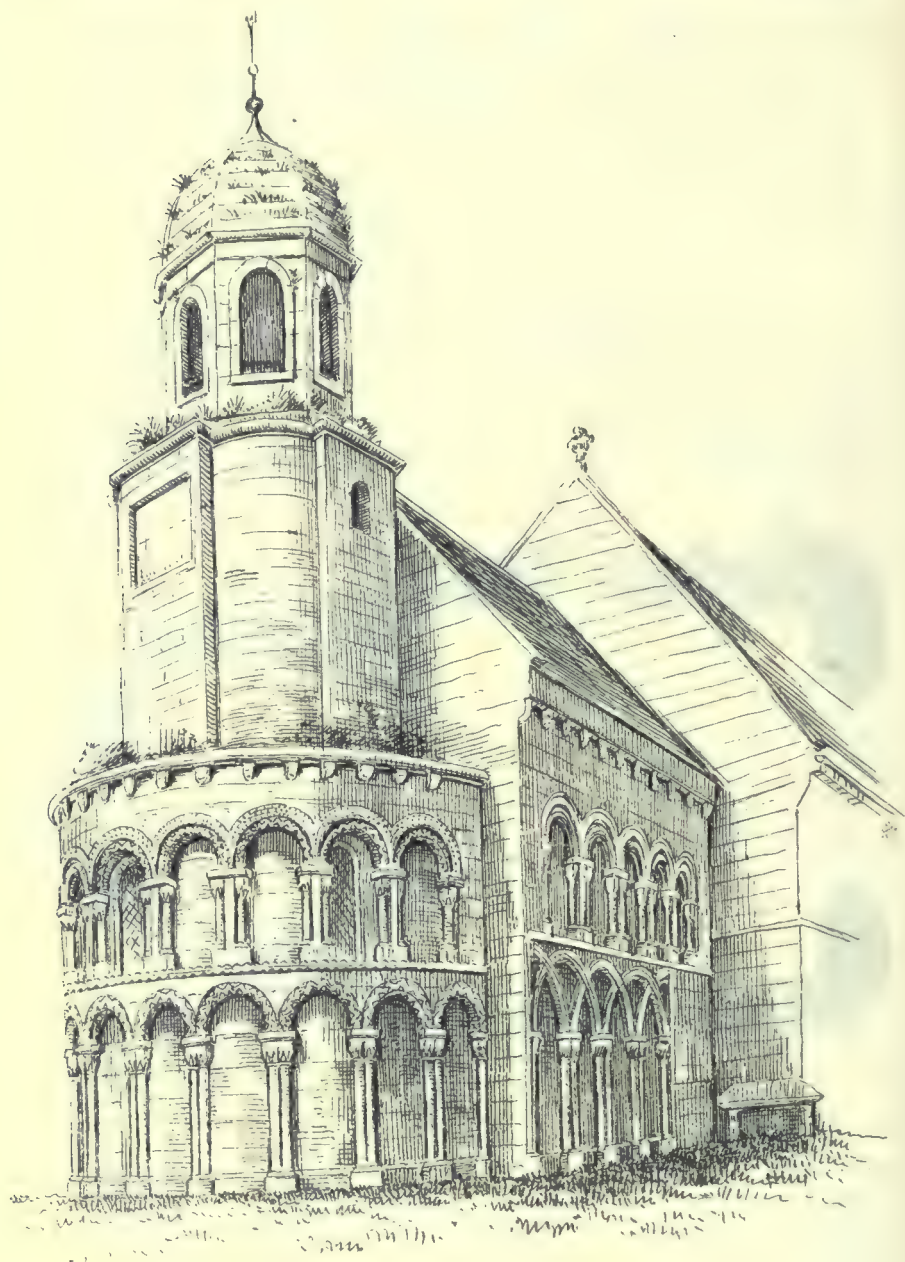
FIG. 264.—Leuchars Church. View from North-East.

The general view (Fig. 264) shows the exterior of the semicircular apse, with its arcade of two stories, the shafts of the upper tier resting on the arches of the lower one, and all the shafts bearing cushion caps. Those of the lower story are double shafts, and those of the upper story are double

shafts, with a broad fillet between them. All the arches are enriched with chevron and billet mouldings, and the upper tier has an extra order of elaborate billet-work. The string course between the two arcades is carved with zigzags (Fig. 265). The cornice is supported on a series of boldly-carved grotesque heads, all varying in design.

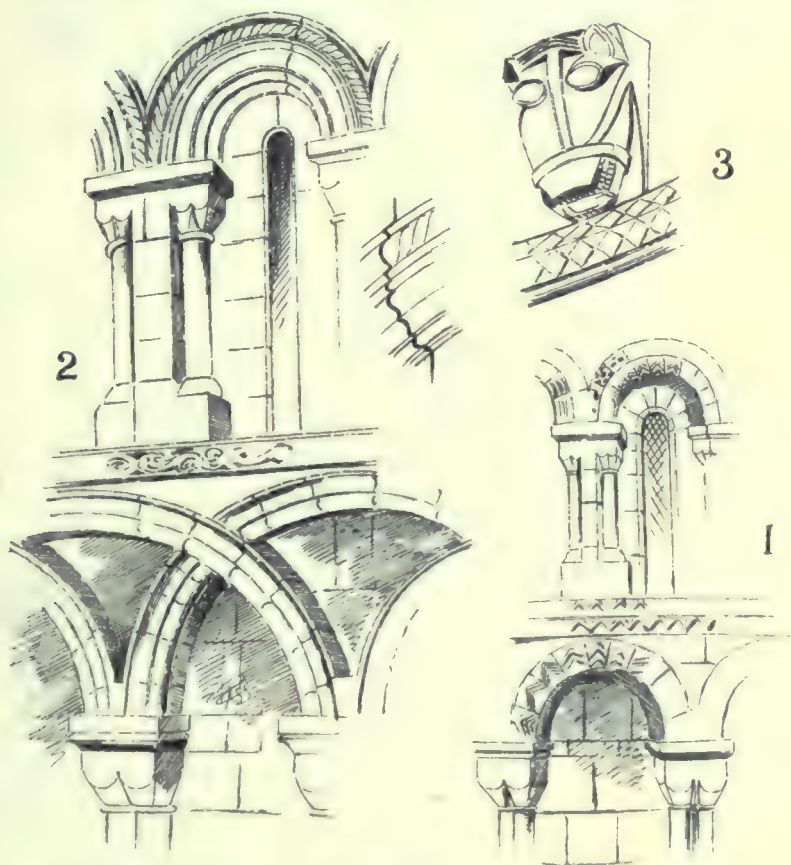
FIG. 265.—Leuchars Church. 1. Details of Apse. 2. Details of Choir. 3. Corbel in Apse.

The chancel is vaulted with heavy moulded groins, springing from the cushion caps of short single shafts resting on grotesque heads. (See Fig. 265.) A small window is introduced in each of the divisions formed by the shafts, and each window has a pair of nook shafts in the interior and enriched arch above. The lower part of the apse is plain, and is separated from the upper part by a string course, enriched with faceted ornaments.

The design of the exterior of the choir (Fig. 267) is similar to that of the apse, there being two arcades, one above the other, surmounted by a cornice, with corbels carved as grotesque heads. The lower arcade, however, has interlacing arches (see Fig. 265), which indicate a late period of the style. The two arcades are separated by a string course, enriched with scroll floral ornament.

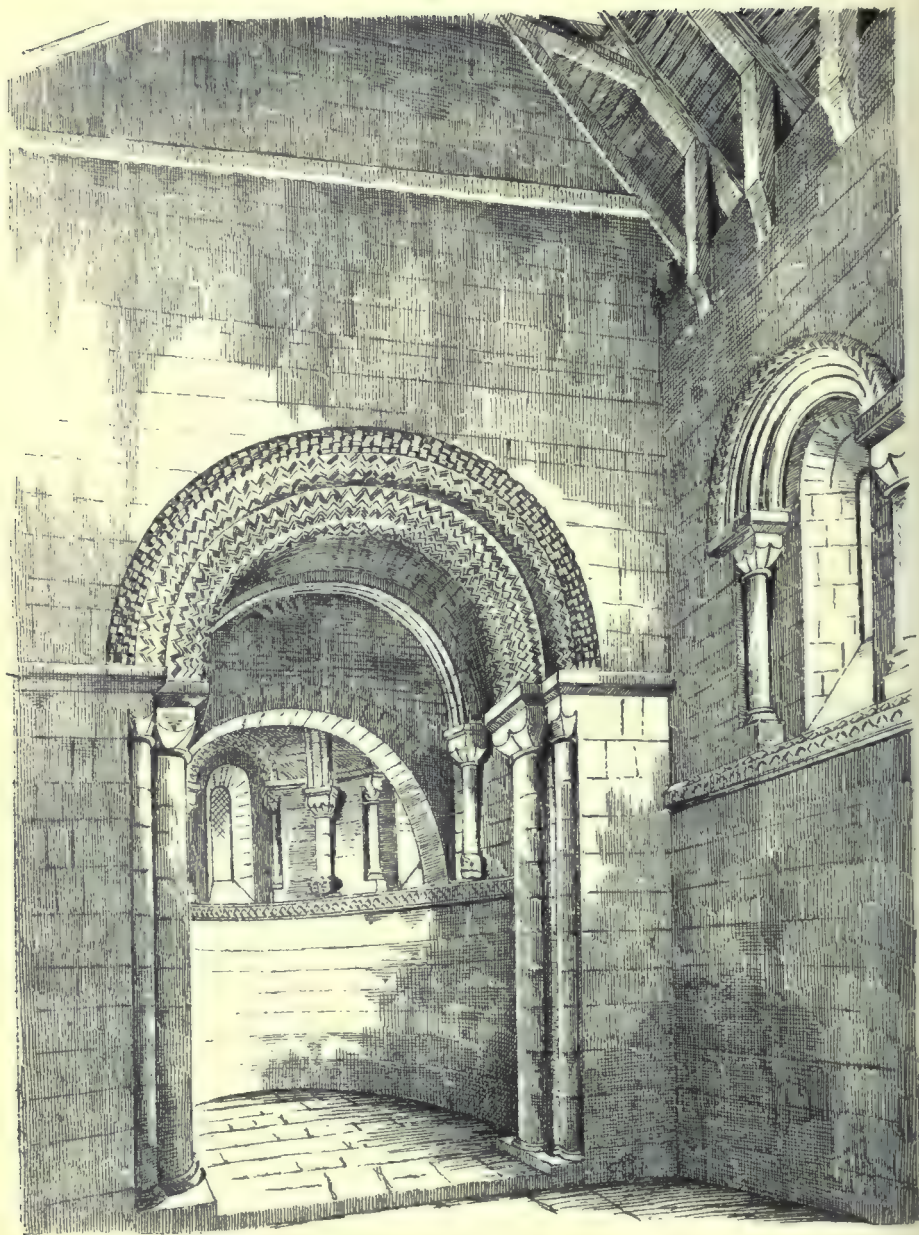
FIG. 266.—Leuchars Church. Interior of Apse.

On the top of the apse vault there has been built, in the seventeenth century, an incongruous turret, which, although not of bad design, is extremely out of place. To support this belfry, a plain arch has been introduced in the interior amongst the Norman work of the apse. (Fig. 266.)

In the interior (see Fig. 266) attention is drawn to the elaborate carving of the chancel arch, which has two orders of complex chevron ornament, and an outer order or hood mould of four rows of billets. The soffit of the arch is also enriched with chevrons, so arranged as to form a row of lozenge ornaments in the centre. The chancel arch is carried on a central attached shaft and two plain nook shafts, built in courses, with simple cushion caps and plain bases.

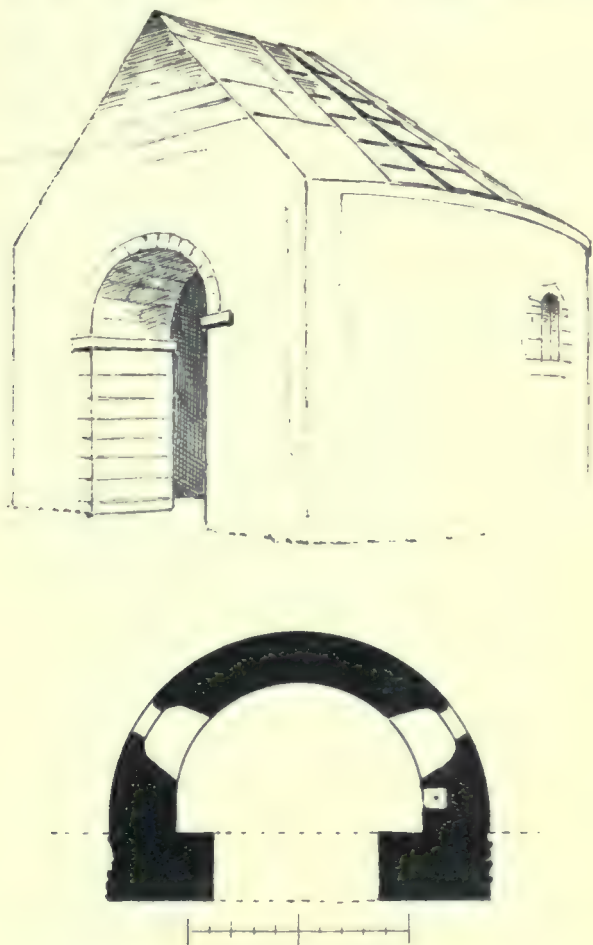
FIG. 268. —Bunkle Church. Plan and View of Apse.

Amongst these fragments, the small piece of Bunkle Church (Fig. 268) which survives is one of the earliest. It is situated about  $4\frac{1}{2}$  miles north-west from Chirnside Station, on the Duns Branch Railway, and stands in the immediate neighbourhood of the fragmentary ruins of

Bunkle Castle. The building appears to have been entire till about 1820, when it was demolished, and the materials used in the erection of the existing parish church, which adjoins it. Only the semi-circular apse, with the arch leading into it, remains of what was the original parish church. The building is extremely plain, and Mr.

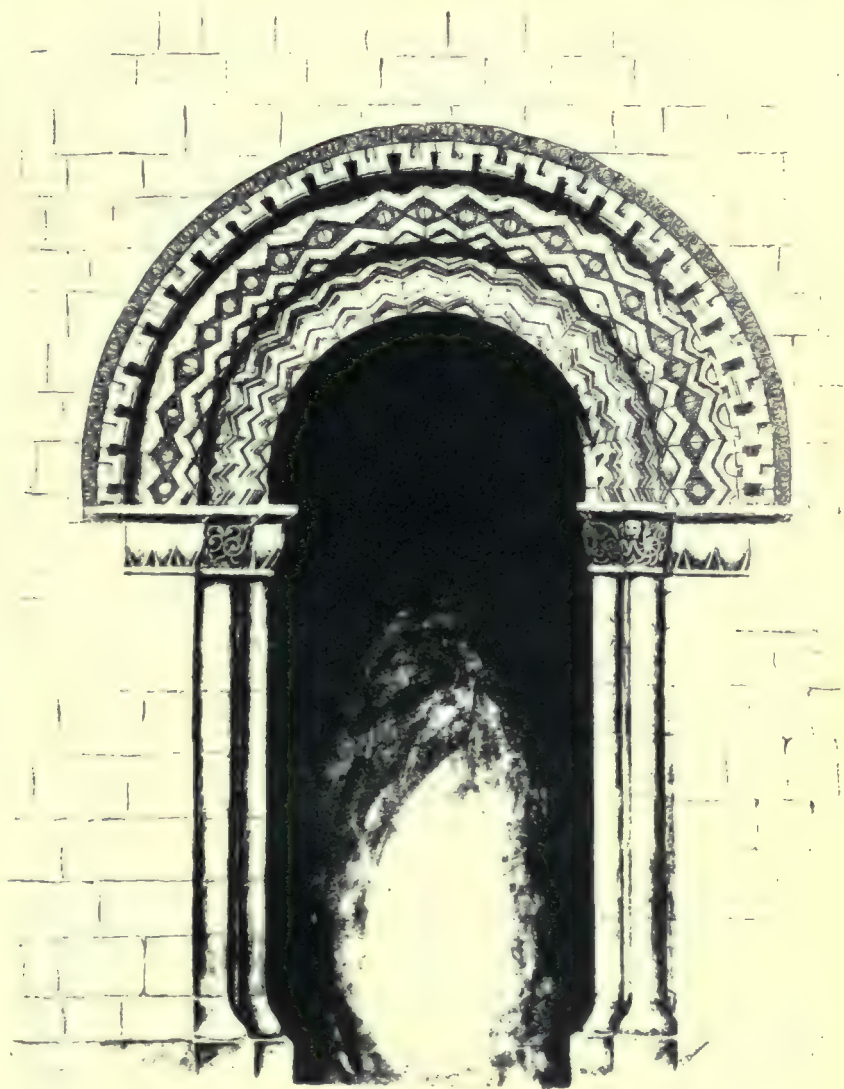
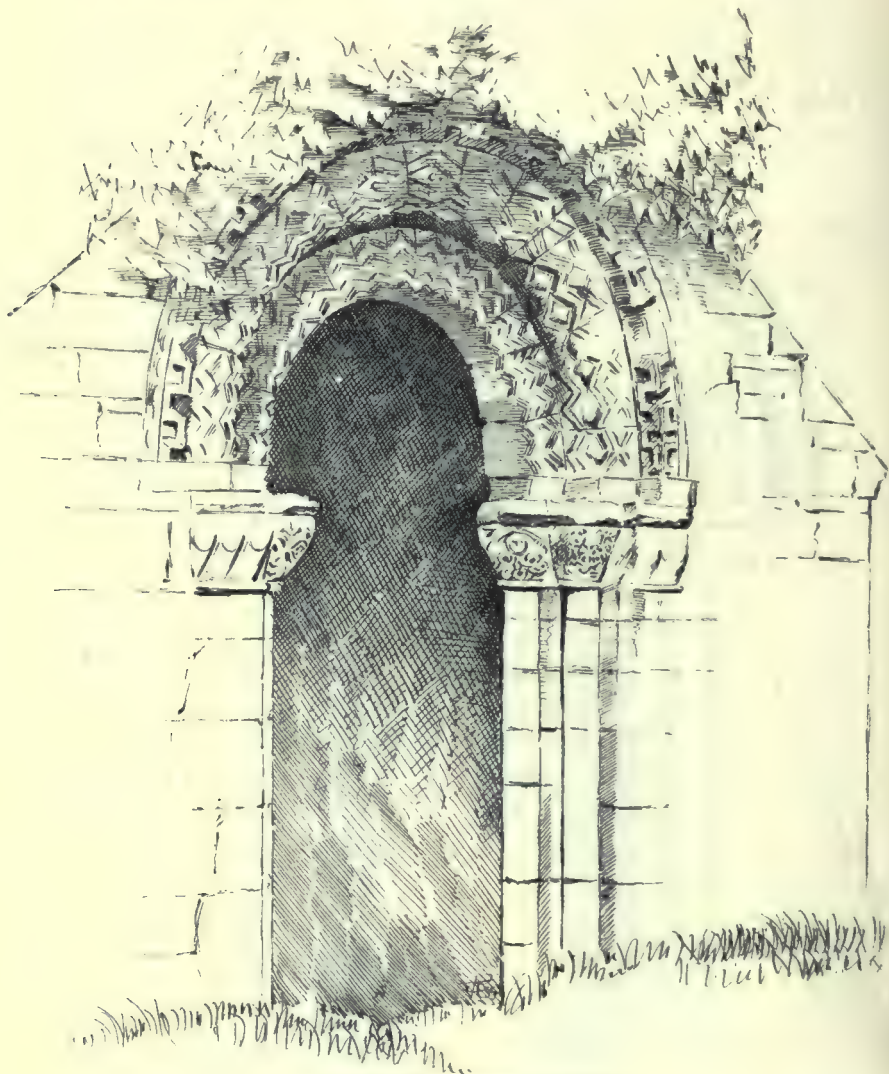
FIG. 269.—Edrom Church. Norman Doorway.

Of the ancient parish church of Edrom, situated about one mile from Edrom Railway Station, there still survives a Norman doorway of beautiful workmanship. (Fig. 269.)† It has been preserved by being made the entrance to a burial vault at the west end of the church. This doorway (Fig. 270) is one of the finest of the style in Scotland, and is of considerable size, being 11 feet high and 4 feet 8 inches wide. It has two shafts (one of them a nook shaft) in each jamb, and the ashlar work of the wall forms the support of the outer order. The arch contains three orders, all elaborately carved with Norman enrichments. The inner enrichment (Fig. 271) consists of a series of chevrons; the central order is also ornamented with two sets of chevrons, arranged so as to form lozenge shapes between them, which are filled with delicate carvings. The outer order contains a repeating ornament, arranged in squares, and the whole is enclosed with a small label carved with a delicately foliated ornament.

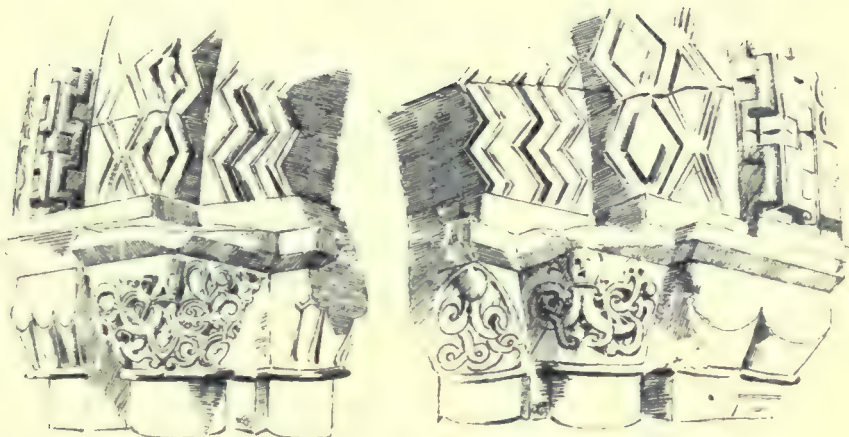
FIG. 271.—Edrom. Caps of Shafts.

The caps of the shafts are somewhat remarkable. Fig. 271 shows those of each side. The cushion caps and the elaborately carved scrolls of the left central cap correspond with ordinary Norman work, but the peculiar and twisted serpent-like forms of the right jamb are remarkable.

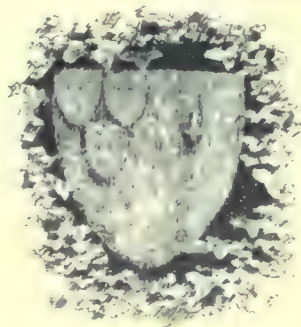
FIG. 274.—Edrom. Shield on Aisle.

An aisle of some interest is attached to the church. It contains in a panel occupying the position of a niche on one of the buttresses a modern inscription giving the history of the aisle, viz.:—"Founded by Robert Blackadder, Archbishop of Glasgow, in the year 1499." The only portions of the aisle still preserved which are of any interest are the two angle buttresses (Fig. 272). Both of these have had niches with canopies and corbels for supporting figures. The canopy of one is gone, but a sundial occupies its place. The archbishop's arms and initials (Fig. 273) are carved on the buttress. His family name is derived from a place of the same designation in the parish. Another shield (Fig. 274), with arms almost obliterated, occurs a little further west.

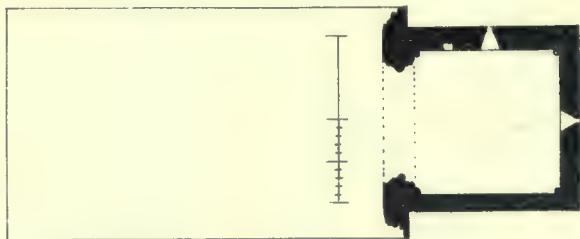
FIG. 275.—Legerwood Church. Plan.

repaired. Attached to it, but entirely cut off by a wall, are the roofless ruins of the original Norman chancel (Fig. 275), which is complete, and measures internally 17 feet 4 inches square. It is fairly preserved, and contains some good Norman work. The chancel arch is entire, but is partly concealed on the face with plaster, and the ingoing is entirely hidden by the stone wall, which separates the chancel from the church. There is a 10 inch diameter round shaft in each internal angle, which is continued up as high as the walls, but there are no indications of vaulting. A small round-headed window, 9 inches wide, is introduced in the centre of the east and north sides (Fig. 276), and apparently a doorway has existed in the south wall. The chancel arch has been large, being about 14 feet 8 inches wide,

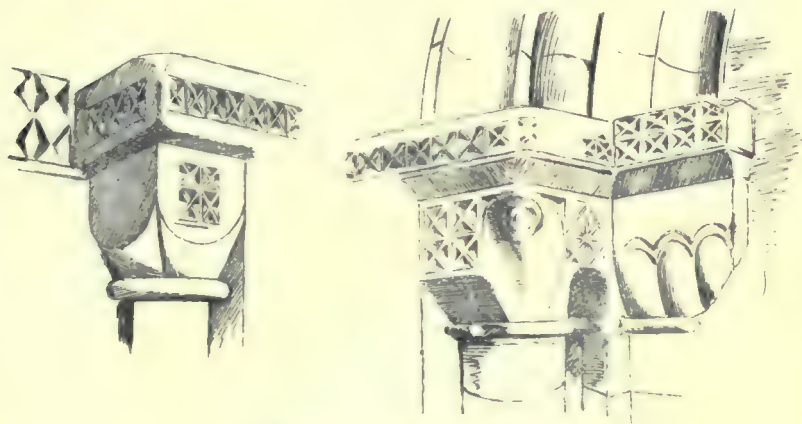
FIG. 277.—Legerwood Church. Caps.

including the columns, and is enriched with shafts and carving; but, unfortunately, it is so built up that only portions are visible. The caps and mouldings, so far as they can be seen, are shown in Fig. 277. The

ornament consists largely of square facets, with various forms of sinkings. A small recess, 11 inches deep, 15 inches wide, and 17 inches high, which occurs in the north wall, is shown in Fig. 278. It has not been fitted with a door.

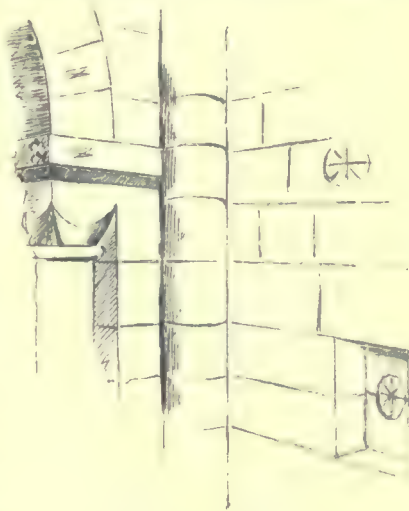
FIG. 278.—Legerwood Church. Recess in North Wall.

Masons' marks are distinctly chiselled on the stones of the chancel. Throughout the chancel there are clear indications of coloured decorations, consisting of a cross or star in red on a circularly-shaped ground of white. Fig. 278 shows one on the wall, and another in the recess.

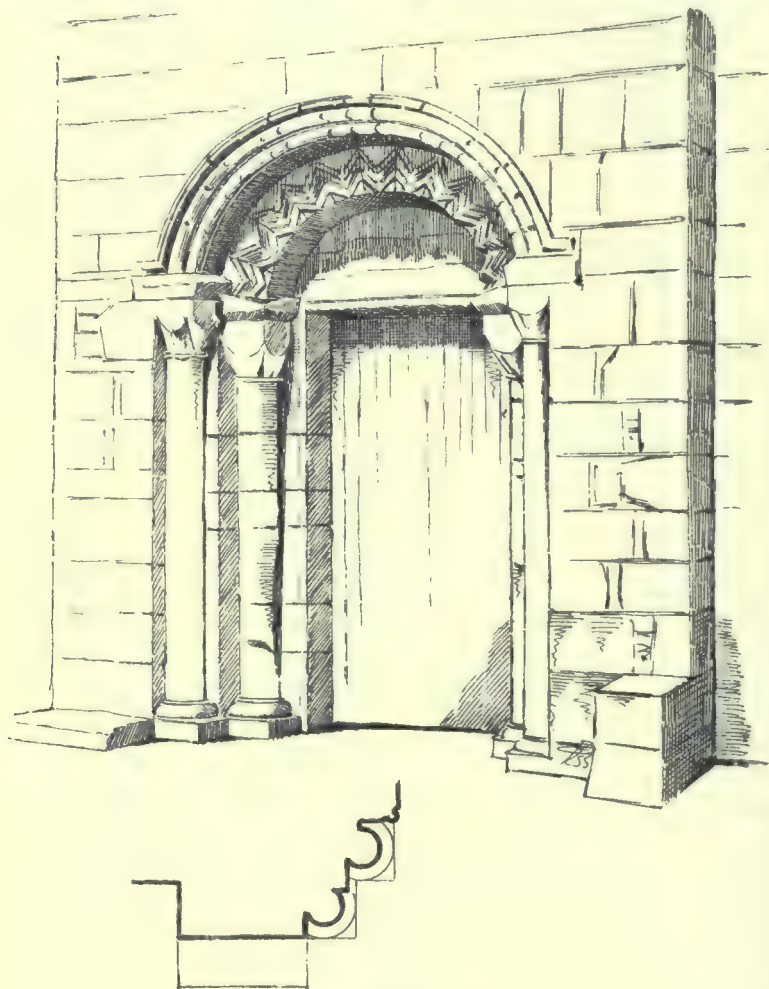
FIG. 279.—Chirnside Church. Doorway.

Railway Station. The village stands high, and commands an extensive view. The church has been much restored, but the ancient Norman walls in great measure remain. Its size can, therefore, be determined, being 78 feet in length by 23 feet  $\frac{1}{2}$  inch in width. The only architectural feature remaining is the doorway on the south side. (Fig. 279.) It is contained in a shallow projection of  $9\frac{1}{2}$  inches, which is 10 feet 2 inches in breadth. The doorway is 2 feet  $10\frac{3}{4}$  inches wide, and the height to the lintel is 6 feet 10 inches. The arched head is somewhat peculiar, consisting of two segmental arches, resting on caps placed at different levels.

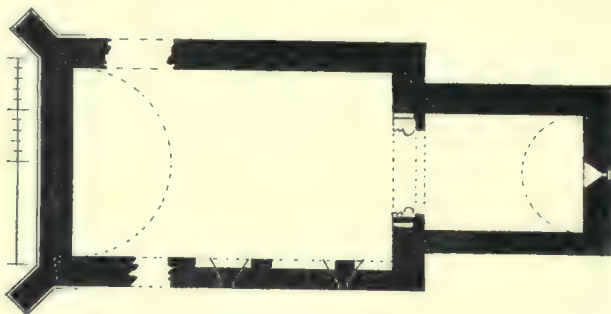
FIG. 280.—St. Helen's Church. Plan.

The church (Fig. 280) was a Norman structure, with the exception of the west gable wall, and consisted of a nave about 30 feet 9 inches long by 18 feet wide, and a chancel 15 feet 2 inches long by 11 feet  $6\frac{1}{2}$  inches

wide. The total internal length was thus about 48 feet 11 inches. The building was barrel vaulted throughout. The apertures where the north and south walls of the nave are shown broken down (see Fig. 280) probably indicate the position of a north and south doorway. There were two win-

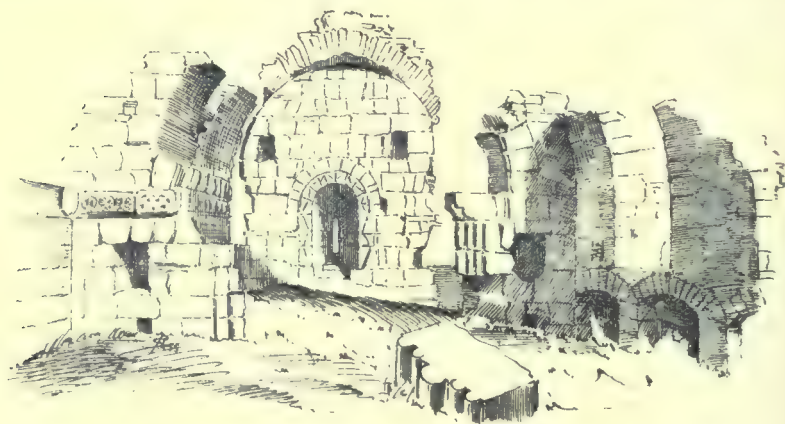
FIG. 281.—St. Helen's Church. View looking East.

dows in the south wall, with three shallow arched recesses beneath. (Fig. 281.) These recesses measure 11 inches deep by about 3 feet high, and have not been fitted with doors. Their purpose is unknown. The chancel arch, when entire, measured about 7 feet in width. The stone shown in

the foreground of Fig. 281 gives an idea of the section of the jambs of the arch, only part of which now remains. A broad band connected with the caps runs along the north and south walls of the nave. The band is decorated with a circular rosette ornament. As will be seen from

this view, the arch was flanked on each side by a square recessed opening, similar in position to those at the chancel arch at Tynninghame, but the recesses at the latter are arched. Beneath each of these there is a small opening, as shown on view, about 6 inches square, which goes into the wall for about two feet, but the place is now too ruinous to permit of the matter being further investigated.

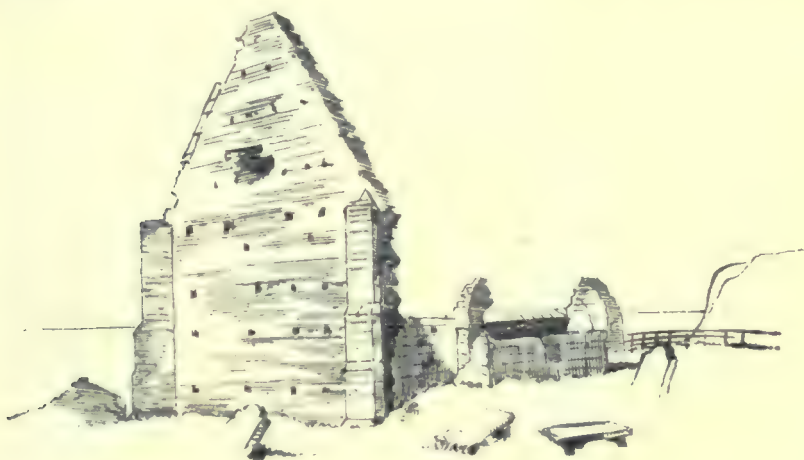
FIG. 282. - St. Helen's Church. West Gable Wall.

The west gable wall (Fig. 282) has been rebuilt in the fourteenth or fifteenth century. It is without opening of any kind, save the numerous putlog holes used for the masons' scaffolding when erecting the building.

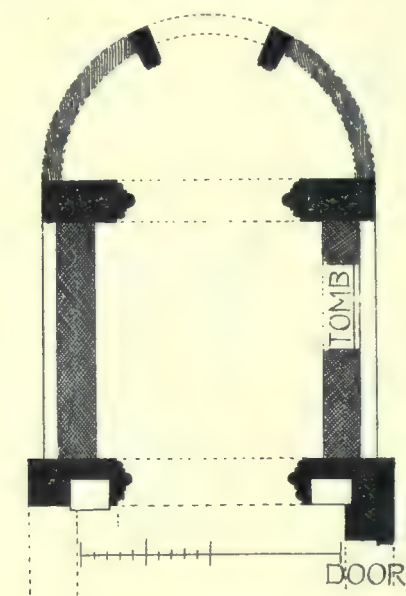
FIG. 283.—Tynninghame Church. Plan.

What remains of the structure is of Norman architecture, and exhibits elaborate ornamental work of that style. The plan of the church (Fig. 283) is in part still traceable. The west end of the choir, with its great arch (Fig. 284), is fairly preserved, and the outline of a rectangular choir, about 18 feet in length by 17 feet in width, is observable, although the side walls are greatly demolished.

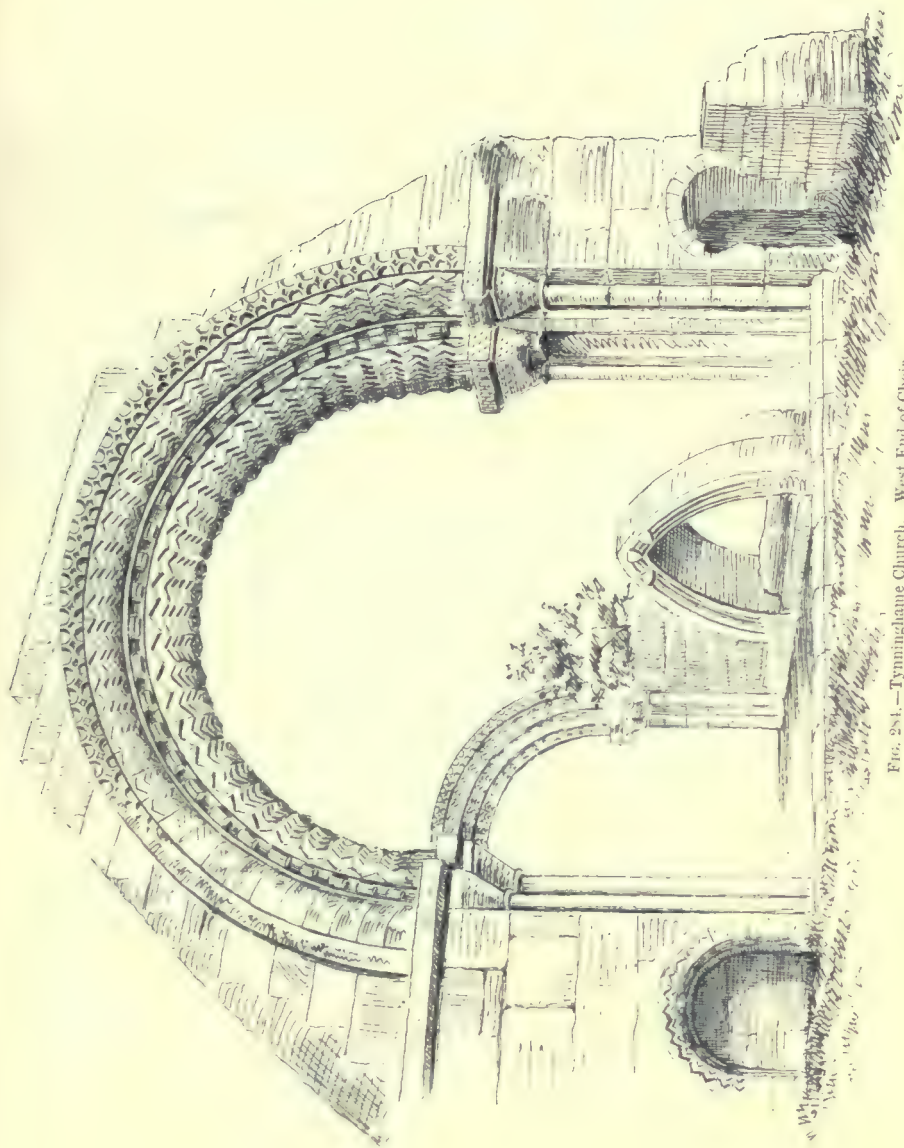
FIG. 284.—Tynninghame Church. West End of Choir

The western arch (see Fig. 284) is supported on a series of nook shafts, some of which are broken away. These carry simply formed caps, with

square abacus, carved with scale work. The arch contains three orders enriched with ornaments and a label. The first and third orders are enriched with very elaborate chevron ornaments; the central order has the billet and the hood mould, a series of small semicircles placed back to back. An arched recess occurs in the wall at each side of the central

arch. That on the north side is original, and is ornamented with the chevron. The arch on the south side has been renewed. It is not clear what purpose these arches served, but most probably they contained altars. Arched recesses in this position, although not common, are sometimes found in Norman churches. The arch of the apse (see Fig. 285) is enriched in three orders, and the caps of the shafts have volutes (Fig. 286). Two of the pillars which formed part of the apse survive. The details of the caps and central band are shown in Fig. 286.

Many of the smaller ornaments of this structure are very beautiful, and are well preserved. On the south side (see Fig. 284) there remains the recessed pointed arch of a monument, in which parts of a decayed recumbent effigy are visible. The three shields on the top give it a picturesque effect.

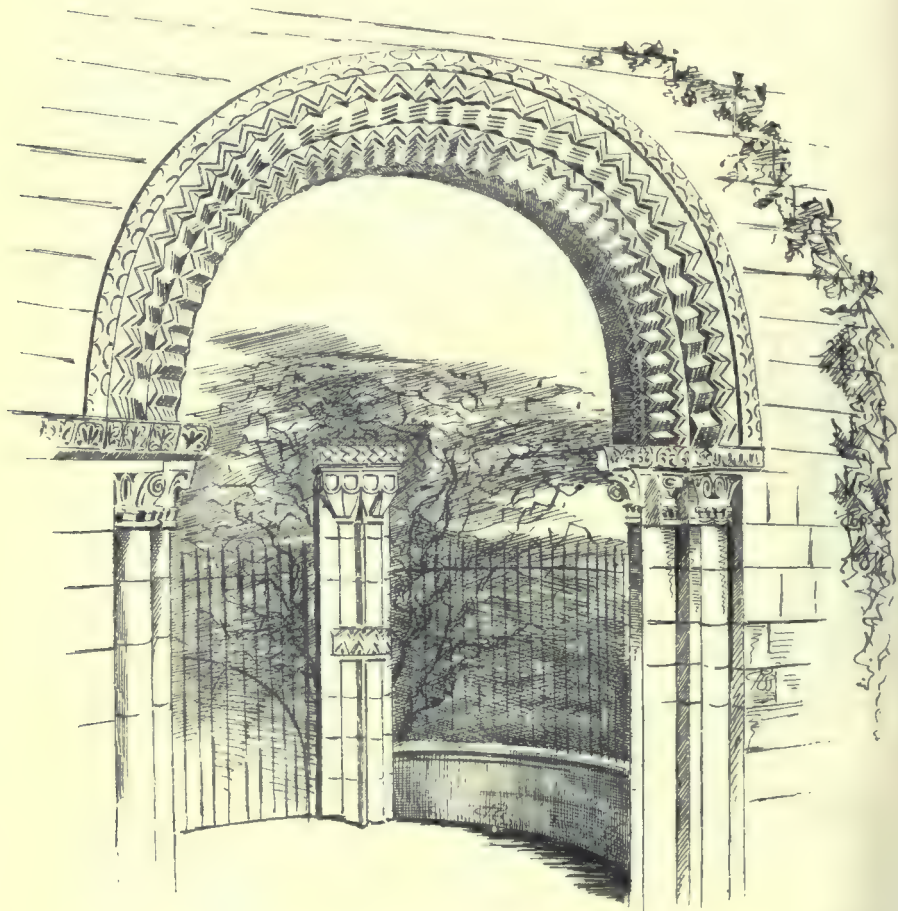
FIG. 285.—Tynninghame Church. Arch of Apse.

The nave, if it ever existed, has entirely disappeared. At the east end an enriched chancel arch still survives (Fig. 285), and also portions of pillars, which indicate that there has been an eastern apse.

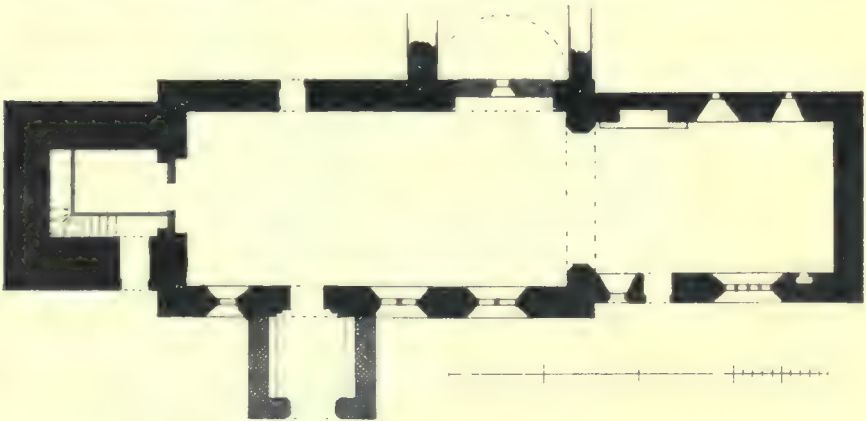
FIG. 287.—Stobo Church. Plan.

The building (Fig. 287) consists of a nave about 40 feet long by 18 feet 7 inches wide, with a chancel about 24 feet 4 inches long by
